# RUSSIAN INTERIM REPORT DETAILS LAST MOMENTS OF FLYDUBAI BOEING 737 CRASH AT ROSTOV

investigating agency: Interstate Aviation Committee (IAC / MAK) – Russia    
report status: Interim  
report number: interim report  
report released: 20 April 2016  
duration of investigation: 32 days (1 months)

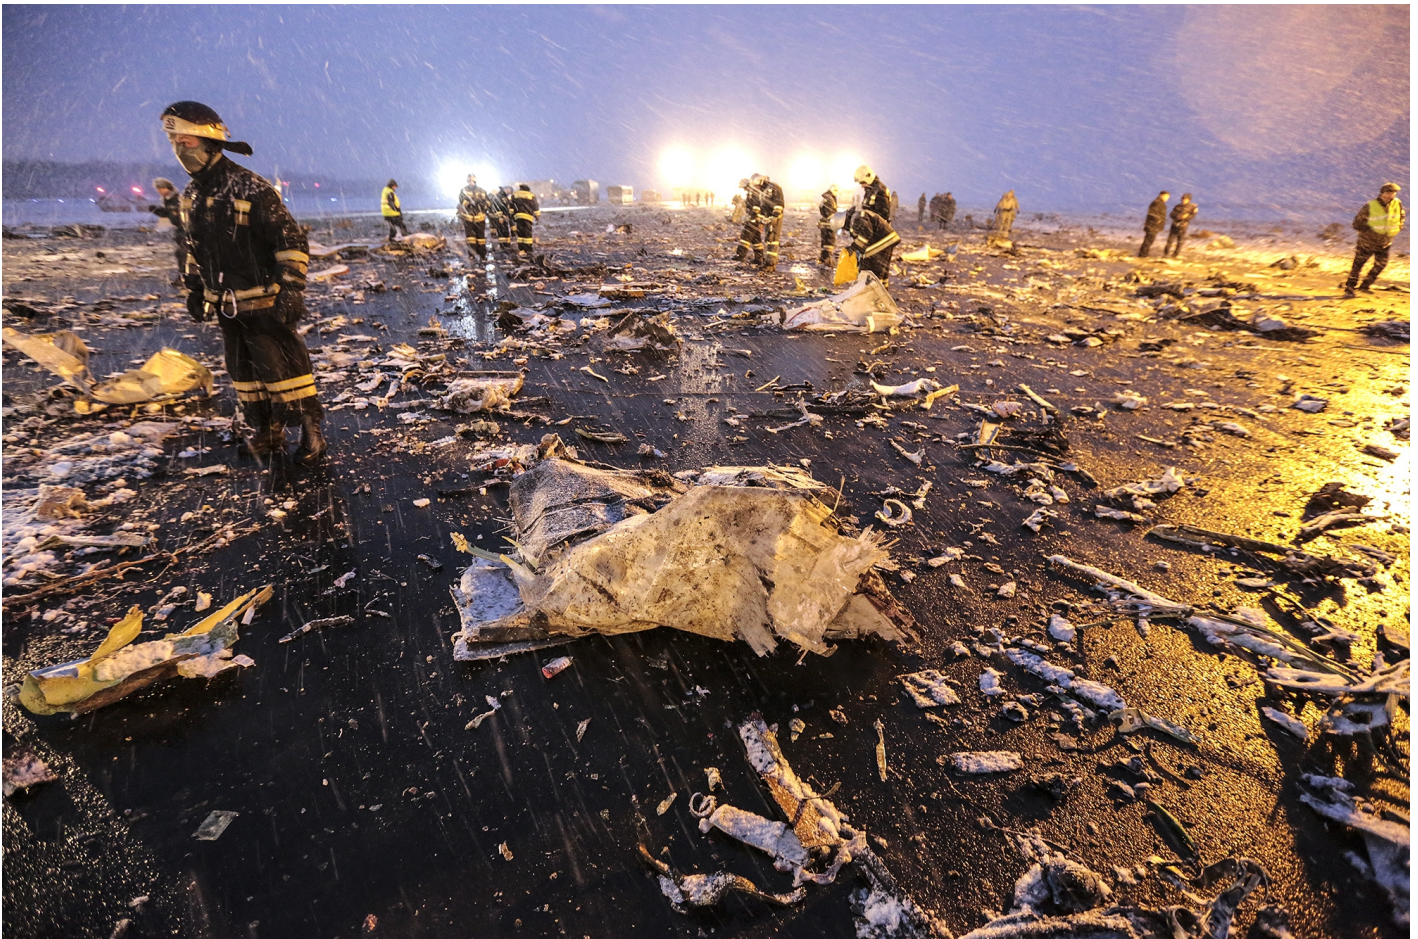
Reconstruction of the aircraft (IAC)

The aircraft hit the runway about 120 m from the threshold with a speed of over 600 km/h and over 50 degrees nose down pitch.
