# WHY DO AIRPLANES STILL HAVE ASHTRAYS?

News / Airlines

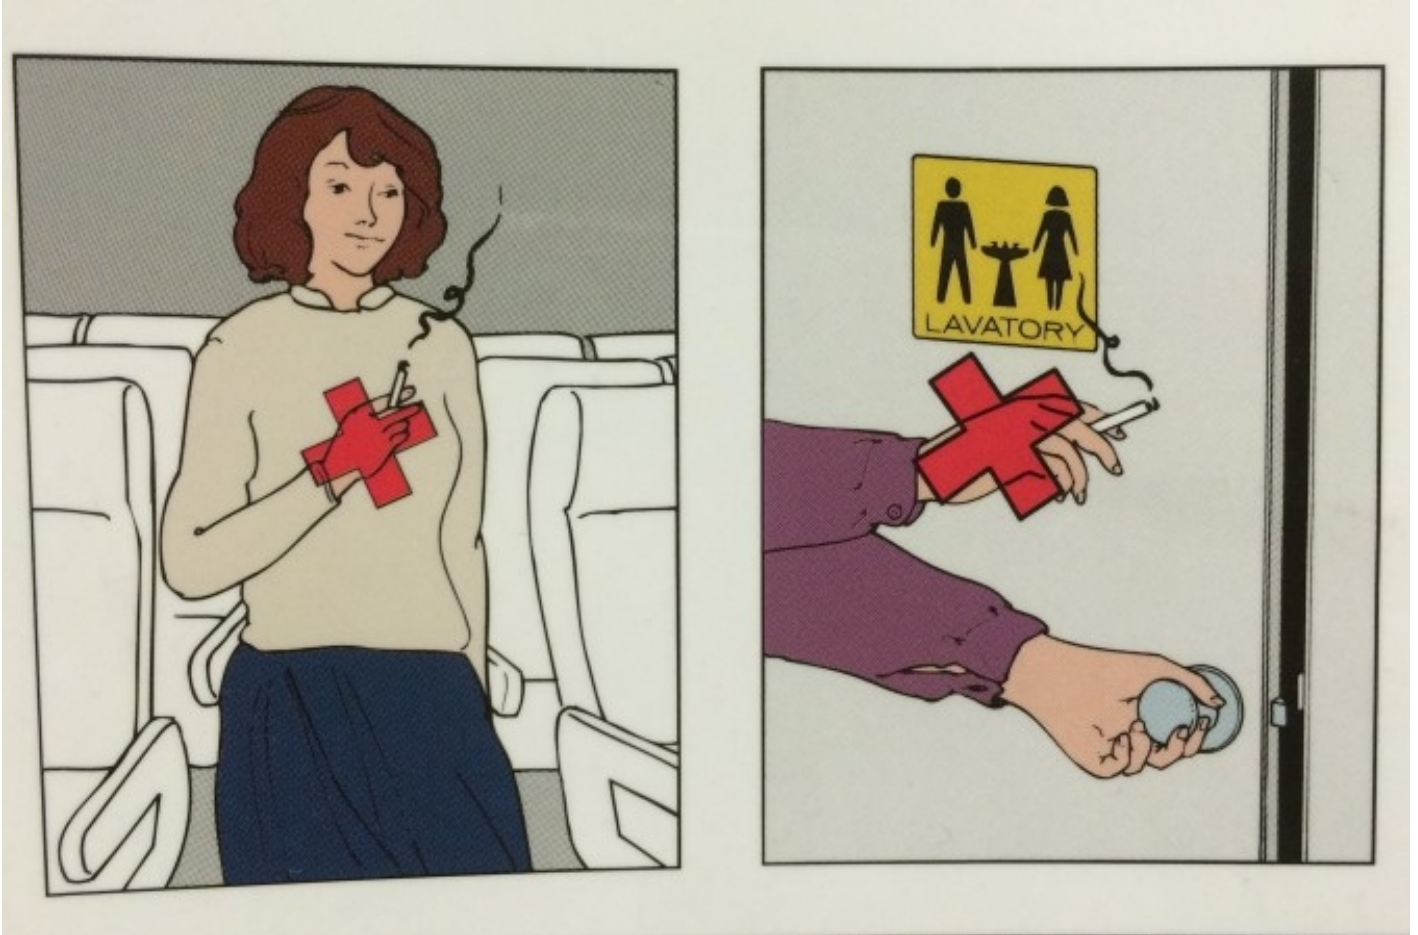
Airplane lavatory no smoking sign (Cindy Drukier/Epoch Times)

“Regardless of whether smoking is allowed in any other part of the airplane, lavatories must have self-contained, removable ashtrays located conspicuously on or near the entry side of each

lavatory door, except that one ashtray may serve more than one lavatory door if the ashtray can be seen readily from the cabin side of each lavatory served.”
