# NTSB RELEASES PHOTOS OF FRACTURED CITATIONJET WINGTIP FOLLOWING TAMPA INCIDENT

News / Business aviation

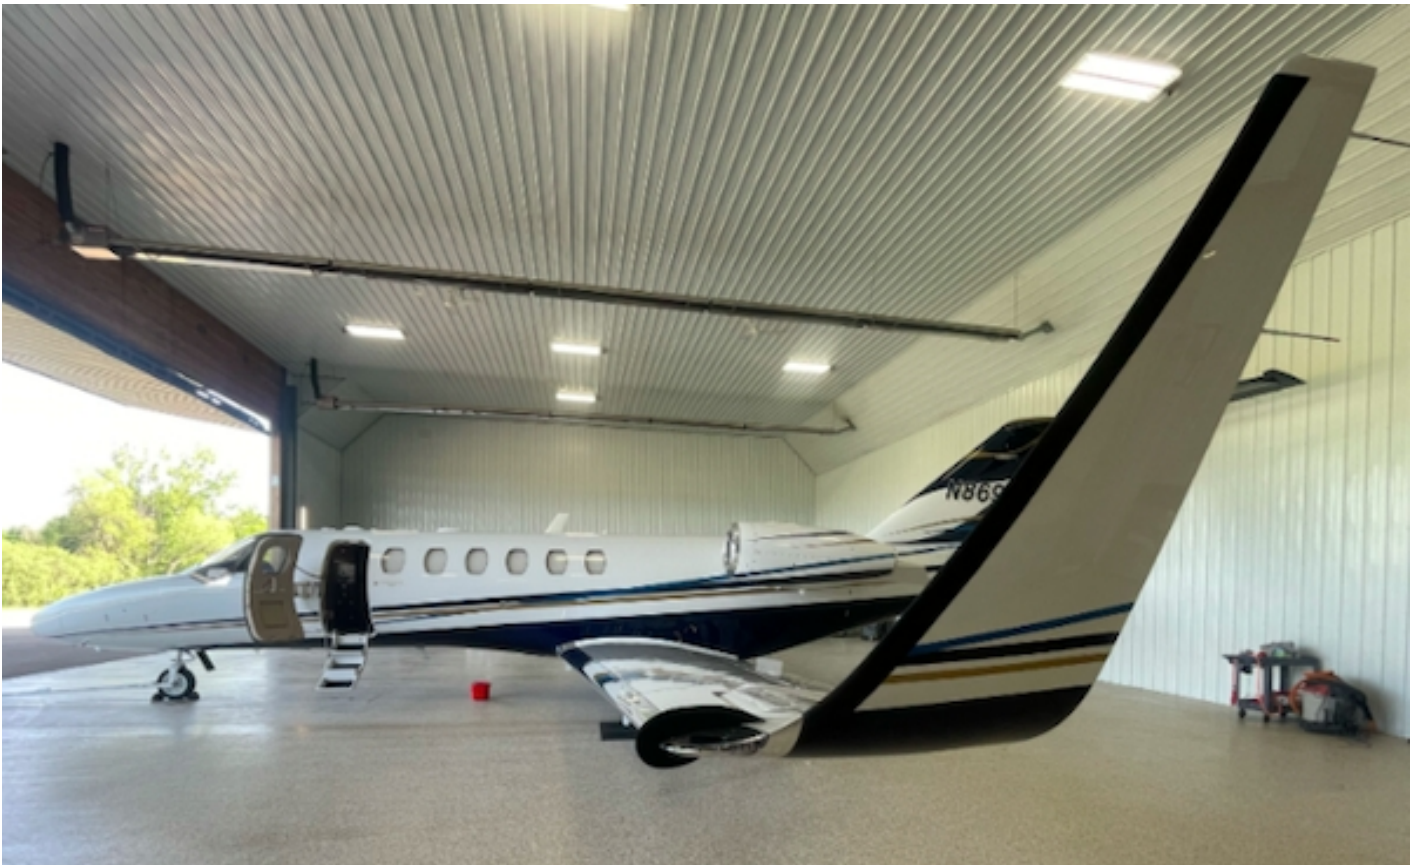
The Left Wingtip was fully restored on this Citation CJ3, and returned to service shortly after the Tampa event. The aircraft owner has three aircraft with the Tamarack upgrade which are used for a combination of air charter, business travel, and personal use. The owner was happy to have the aircraft restored, "It looks a lot better with two winglets!" The recent round of content released by the NTSB also includes photos of the wingtip, clearly showing that the wing extension missing from the aircraft, just a few inches from the aileron.

Almost exactly one year after an event in Tampa, Florida the NTSB has posted detailed documents and photos related to the March 30, 2024 incident where a CitationJet safely landed with nearly 70 inches of wingtip missing. The package from the NTSB includes a detailed Systems Factual Report which details extensive testing of the Tamarack equipment. Testing and inspection revealed “no anomalies” and each unit passed functional testing, which builds on [previous reports](#) finding no anomalies in the Tamarack equipment. The entire docket of information released by the NTSB can be found [here](#).

Shortly after the initial inspection in Tampa, the owner ferried the aircraft from Tampa to Fort Lauderdale, with the entire wingtip missing. The move was supported by FAA and Tamarack because FAA certification included successfully flight testing a one winglet removed scenario simulating a bird-strike, ground damage, lightning strike, or any other abnormal, external event damaging the winglet, proving ample safety margin even in an unlikely emergency scenario. The aircraft was repaired and returned to service soon after the relocation flight.
